RECORD OF SURVEY NO. 31-45

SHEET 5 OF 9

SECTIONS 21/22/27/28, TOWNSHIP 7 NORTH, RANGE 23 EAST, M.D.B. & M.

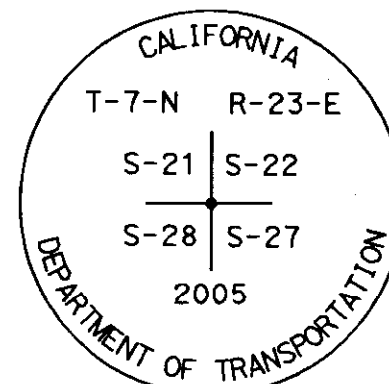
RESET COR SECS 21/22/27/28
ORIGINAL BLM BRASS CAP
DESTROYED DURING 1999 FLOOD.
SET CALTRANS BRASS CAP ON
2 1/2" O.D.I.P.
N. 108,766.150
E. 100,279.776

NOTE: POINT RESET BY COORDINATES.
COORDINATES THAT WERE USED TO
RESET NEW CORNER WERE PREVIOUSLY
COLLECTED IN A CALTRANS SURVEY
PRIOR TO ORIGINAL CORNER BEING
LOST IN 1999 FLOOD.
